National Transportation Safety Board

Aircraft Accident Investigative Update

On January 26, 2020, at 0945 Pacific standard time (PST), a Sikorsky SK76B helicopter, N72EX, collided with hilly terrain near the city of Calabasas, California. The pilot and eight passengers were fatally injured, and the helicopter was destroyed by impact forces and fire. The helicopter was operated by Island Express Helicopters Inc. under Title 14 Code of Federal Regulations (CFR) Part 135 as an on-demand passenger visual flight rules (VFR) flight from John Wayne-Orange County Airport, (KSNA), Santa Ana, California, to Camarillo Airport, (KCMA), Camarillo, California.

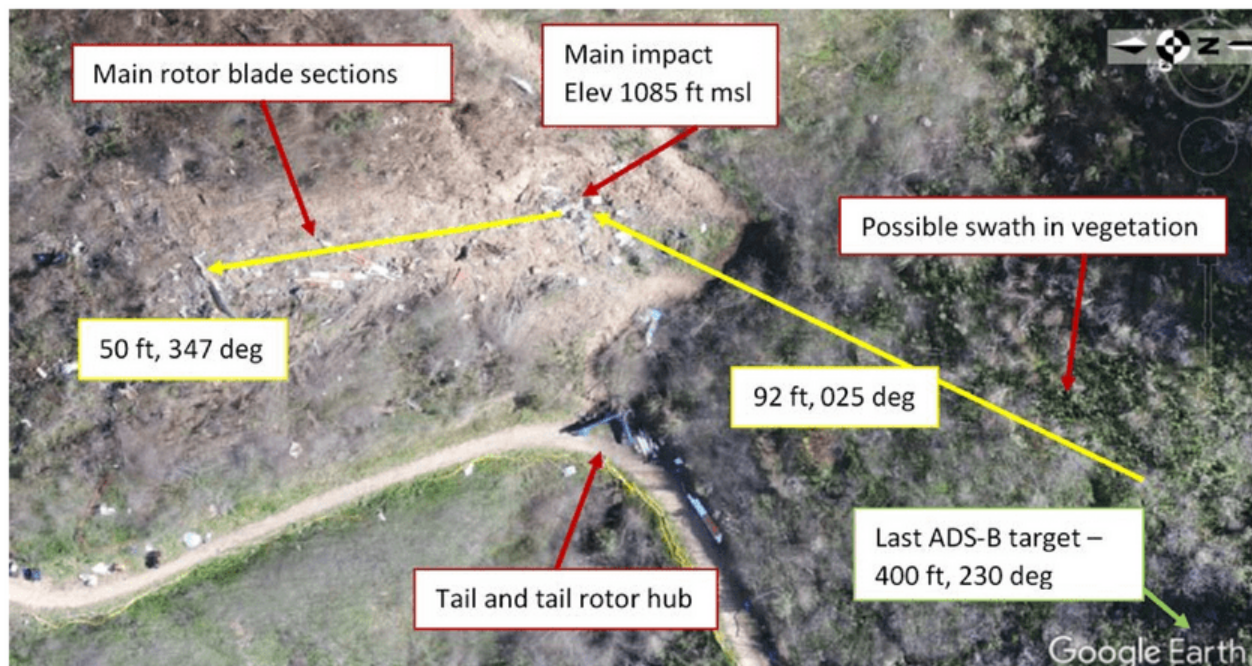
Figure 1a. Google Earth map of wreckage area – southern (directions reference true north)

The wreckage was located in the foothills of the Santa Monica mountains, in a mountain bike park. The impact site was on an approximate 34° slope. The impact crater was 24 feet-by-15 feet in diameter and 2 feet deep.

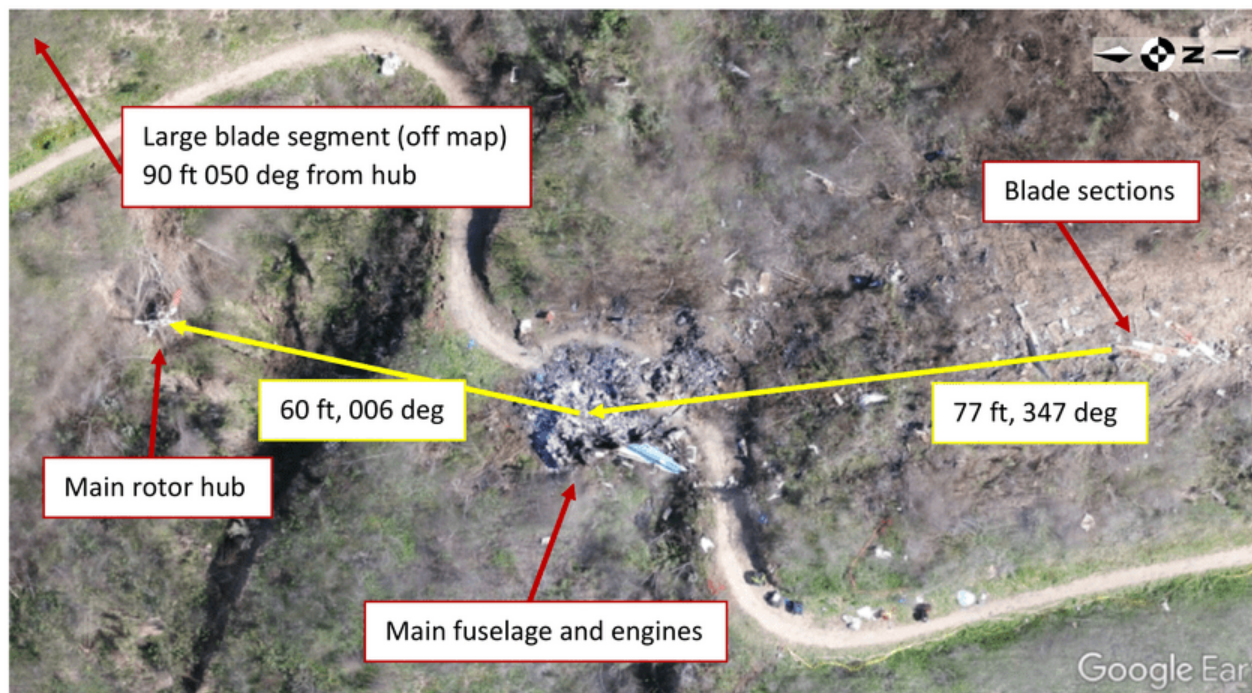
Figure 1b. Google Earth map of wreckage area – northern

All significant components of the helicopter were located within the wreckage area. Examination of the main and tail rotor assemblies found damage consistent with powered rotation at the time of impact. The initial point of impact consisted of highly fragmented cabin and cockpit debris. The vertical pylon and horizontal stabilizer were located about 40 feet below (downhill from) the

impact crater. A witness mark consistent with the length and width of a rotor blade and containing fragments of rotor blade skin and honeycomb was positioned perpendicular to the direction of the debris line and directly above the impact crater. One piece of 2-inch diameter tree branch was cut cleanly in 3 locations (similar to saw cuts) about 30 feet prior to the initial impact crater. Approximately 95% of the main rotor blades were recovered. All four blades exhibited similar damage consisting of midspan bending, pocket separation, blade tip separation, and leading-edge indentations and scuffing.

The main wreckage was about 127 feet from the impact crater along a 347° true bearing (335° magnetic) and consisted of the empennage/tailboom, both engines, avionics boxes, and portions of the cockpit instrument panel. The entire fuselage/cabin and both engines were subjected to a postcrash fire. The cockpit was highly fragmented. The instrument panel was destroyed and most instruments were displaced from their panel mounts. Flight controls were fragmented and fire damaged.

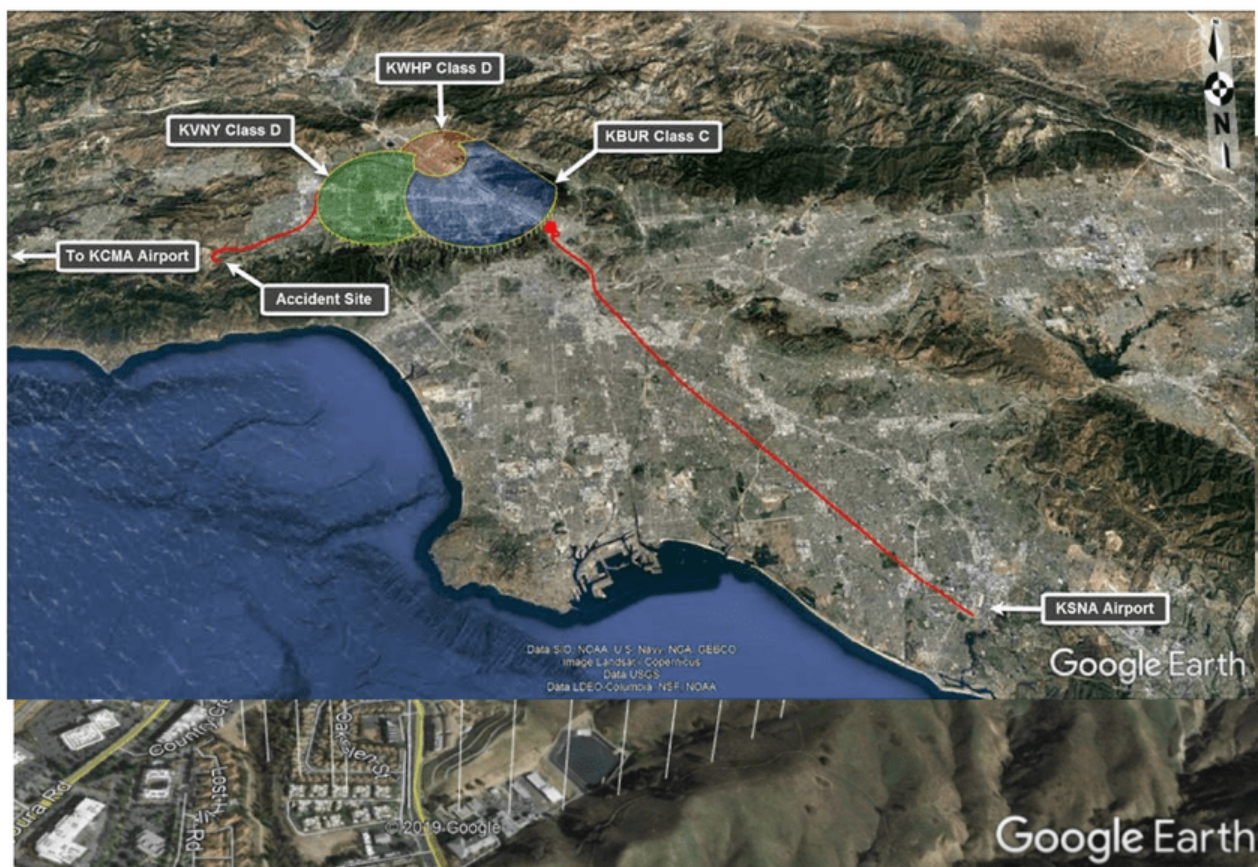
Figure 2. Overall Radar/ADS-B track of N72EX

Radar/ADS-B data indicate the aircraft was climbing along a course aligned with Highway 101 just east of the Las Virgenes exit. Between Las Virgenes and Lost Hills Road, the aircraft reached 2,300 feet msl (approximately 1,500 feet above the highway, which lies below the surrounding terrain) and began a left turn. Eight seconds later, the aircraft began descending and the left turn continued. The descent rate increased to over 4,000 feet per minute (fpm), ground speed reached 160 knots. The last ADS-B target was received at 1,200 feet msl approximately 400 feet southwest of the accident site.

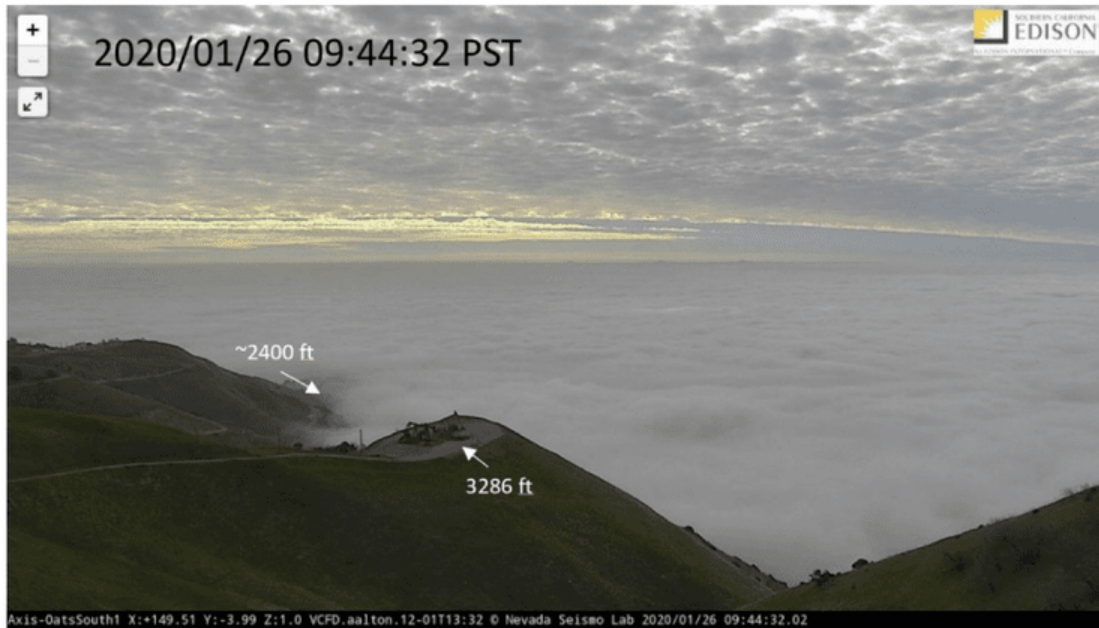
Figure 4. Camera image from 0944 PST

An ALERTWildfire camera image (figure 4) taken at 0944 PST looking southeast toward the city of Van Nuys, as publicized on the National Weather Service (NWS) Los Angeles Twitter account, depicted the top of the cloud layer to the east of the accident site. The NWS analyzed the top of the cloud layer to be about 2,400 feet above mean sea level near the terrain in the foreground of the image.
