# Aviation Investigation Preliminary Report

<b>Location:</b>	Scottsdale, AZ	<b>Accident Number:</b>	WPR25FA088
<b>Date &amp; Time:</b>	February 10, 2025, 14:38 Local	<b>Registration:</b>	N81VN
<b>Aircraft:</b>	GATES LEARJET CORP. 35A	<b>Injuries:</b>	1 Fatal, 3 Serious, 1 Minor
<b>Flight Conducted Under:</b>	Part 91: General aviation - Executive/Corporate

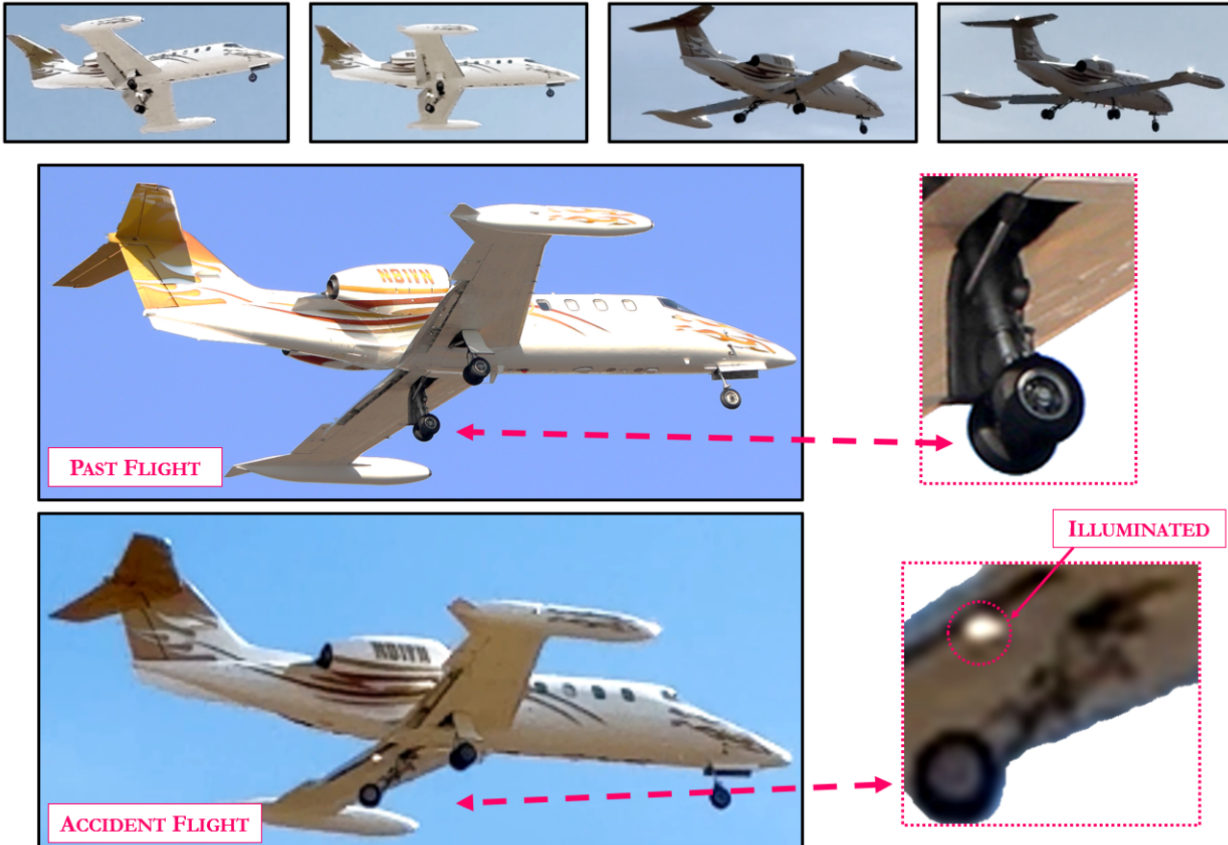
Investigators obtained security camera footage and numerous videos from personal cell phone cameras. A witness provided video taken from a golf course near the final approach path that captured the airplane for 11 seconds starting at 1437:52. The airplane can be seen on final approach with the left landing gear trailing aft from its normal position. Additionally, there is a circular bright spot seen above the landing gear strut, consistent with the landing gear light illuminating the bottom of the wing flap and the landing gear strut positioned facing aft (see figure 1).

Figure 1: Excerpts from a witness supplied video showing the left landing gear askew while on approach to the runway. (Past Flight Photo Source: [www.jetphotos.com](http://www.jetphotos.com))

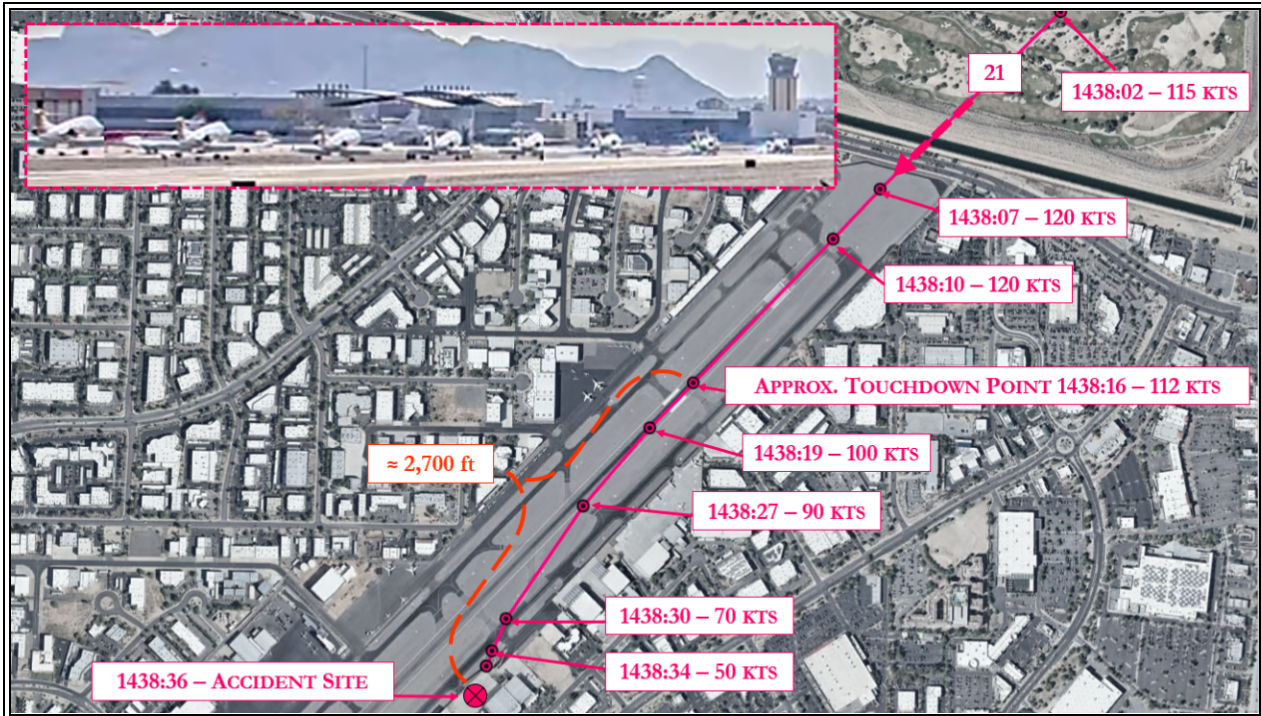
A review of surveillance videos and ADS-B data showed that at 1438:16, the airplane touched down on runway 21 just before the aiming point markings with full flaps extended. It immediately entered a left-wing-low attitude and began veering left, exiting the runway surface. The airplane traveled over the rock-covered runway-safety-area islands located between the runway and taxiways. The airplane crossed Taxiway Bravo, collided with the windsock, and entered the ramp area where it struck the right side of a parked Gulfstream G200 (see figures 2 and 3). The airplane was not equipped with thrust reversers and the drag chute was not deployed.

Figure 2: ADS-B derived flight path and groundspeeds with video excerpts showing the airplane at touchdown

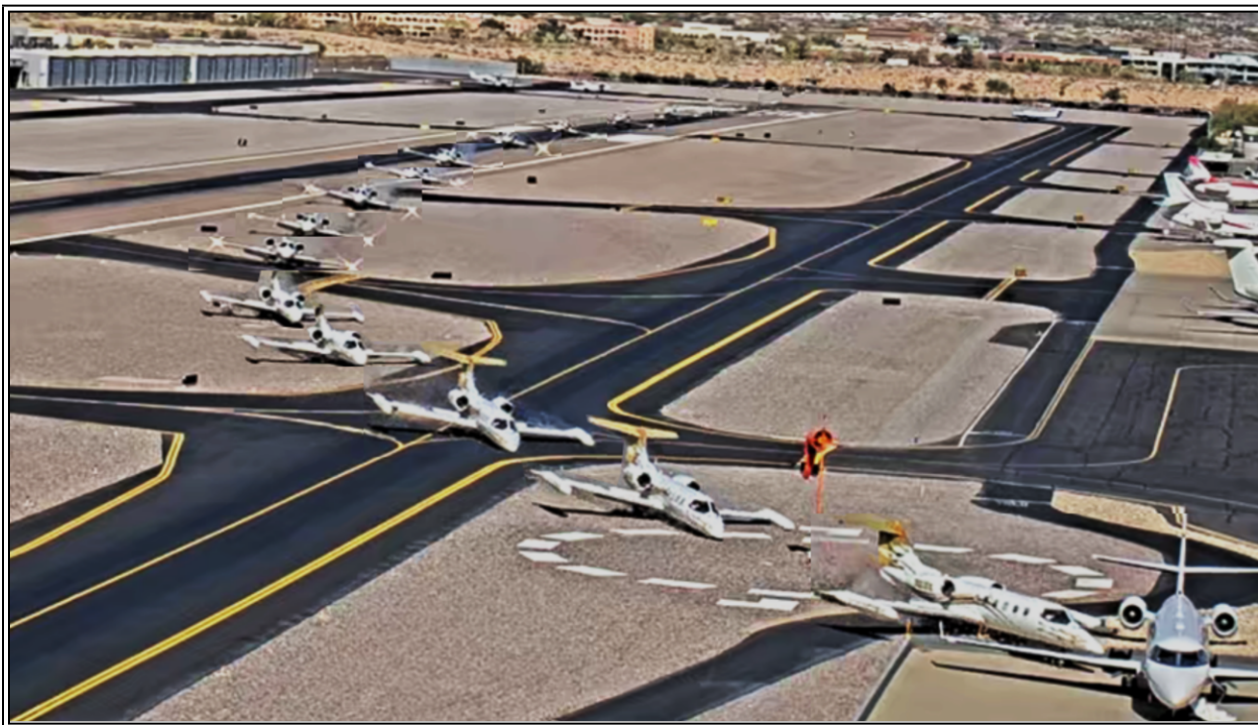
Figure 3: Video excerpts showing the landing rollout to impact

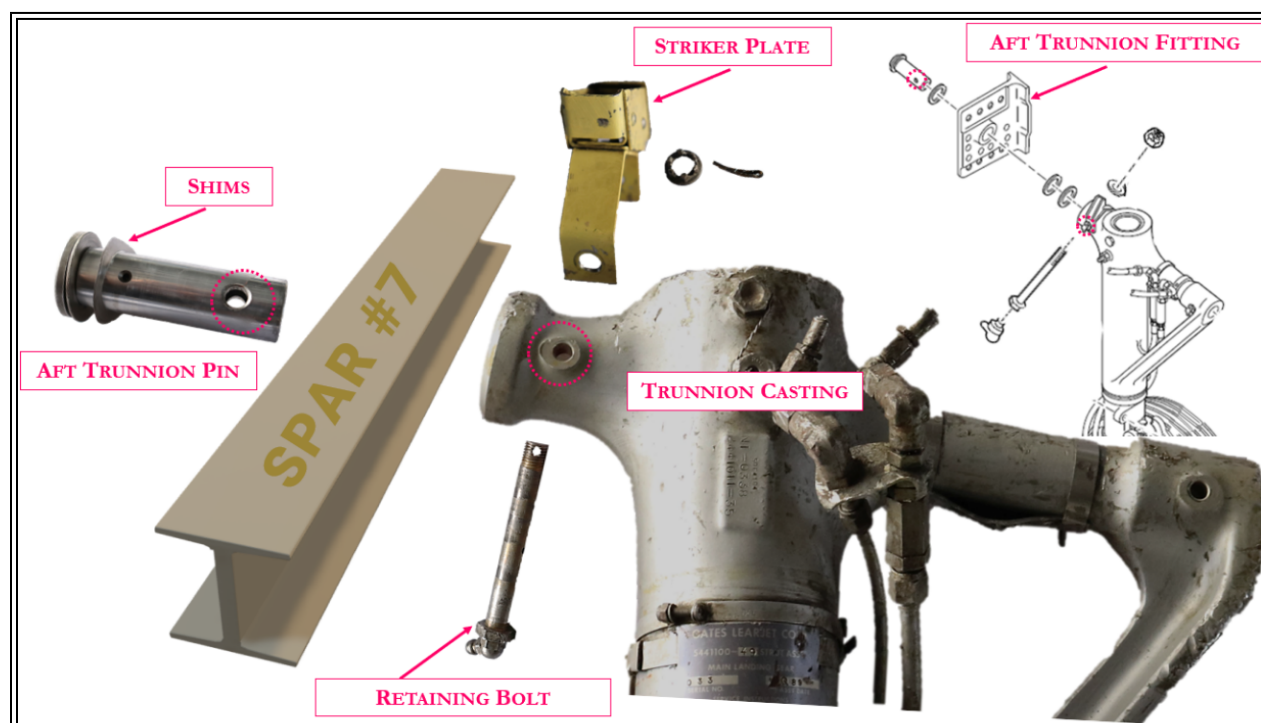
Figure 4: Left main landing gear assembly

The airplane is equipped with a retractable, tricycle landing gear that is electrically controlled and hydraulically actuated. Each main gear assembly consists of a conventional oleo shock strut, dual forged wheels with multiple-disc brakes, a main gear actuator, and inboard/outboard doors hinged at the wing structure. The assembly attaches to the airplane structure through trunnion pins, with striker plates on the trunnions to actuate microswitches. The aft trunnion pins are positioned with the shoulder abutting the aft trunnion fitting (located on spar #7) and the body is aligned forward through a bushing (where there is a grease hole on the pin) and into the aft trunnion casting (see figure 4). There are shims that are placed on the pin and positioned on both sides of the aft trunnion fitting to ensure adequate movement. The pin is secured to the trunnion with a retention bolt that goes through the striker bracket, trunnion, and the pin's retention bolt holes, which is then affixed with a castellated nut and cotter pin.

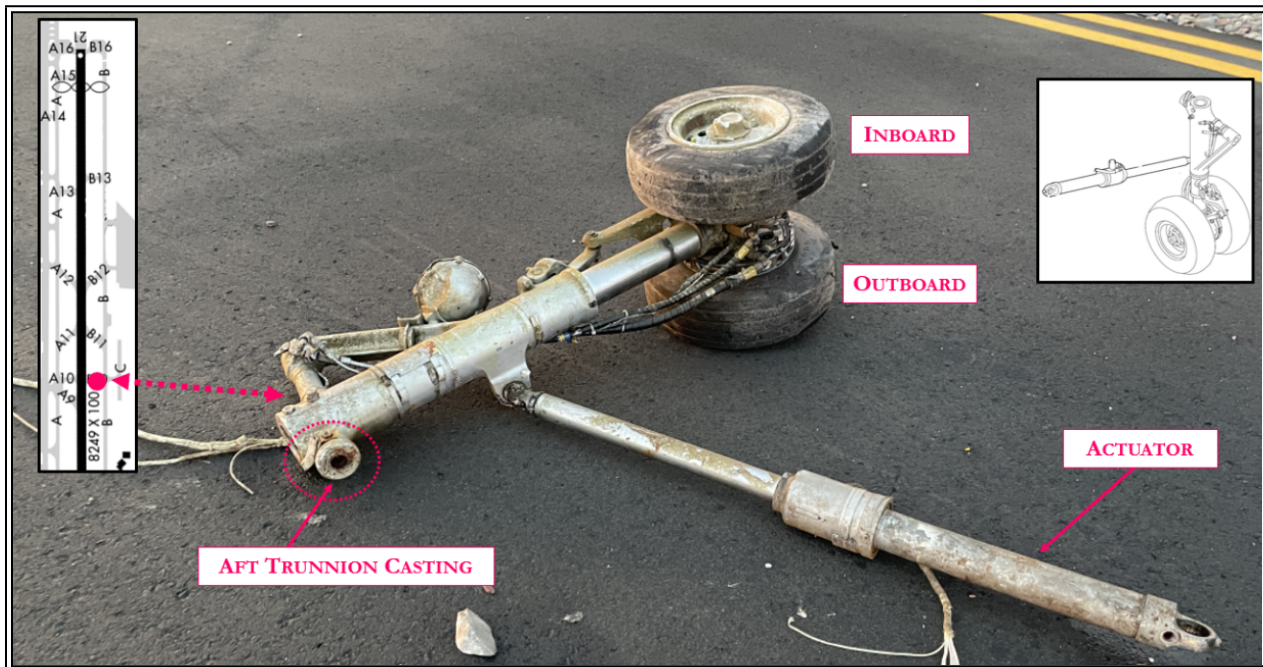
The left main landing gear came to rest on Taxiway Bravo 10 adjacent to Taxiway Bravo (see figure 5). The forward trunnion pin remained secured in the forward trunnion casting. The aft trunnion pin was

Figure 5: Left main landing gear at the accident site

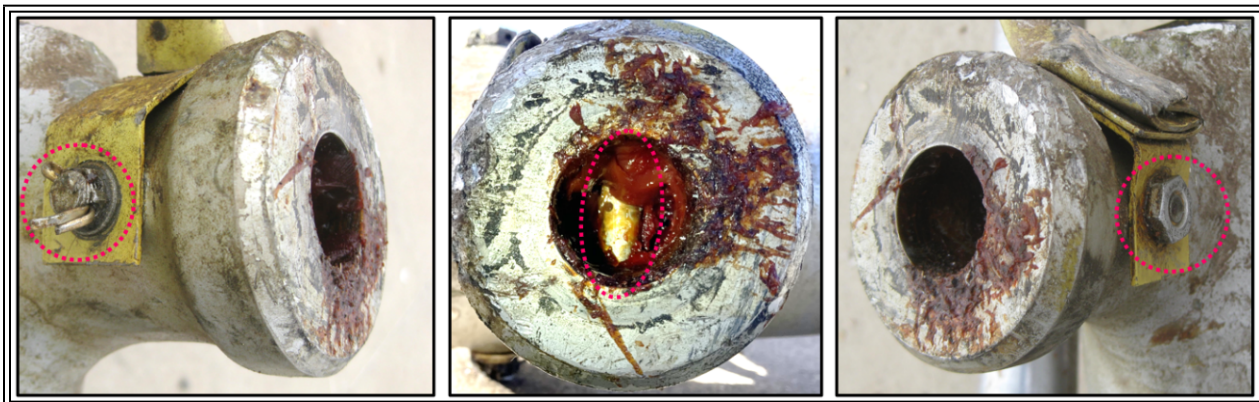
not present within the trunnion casting, though the retaining bolt with striker bracket was secured with the castle nut and cotter pin (see figure 6). The actuator remained connected to the strut, but the inboard attachment point was no longer fastened to the airframe. The right main landing gear remained attached to the airframe and was in the down and locked position with the outboard gear door separated and located within the debris field and the inboard door in the locked position.

Figure 6: Left main landing gear aft trunnion casting at the accident site

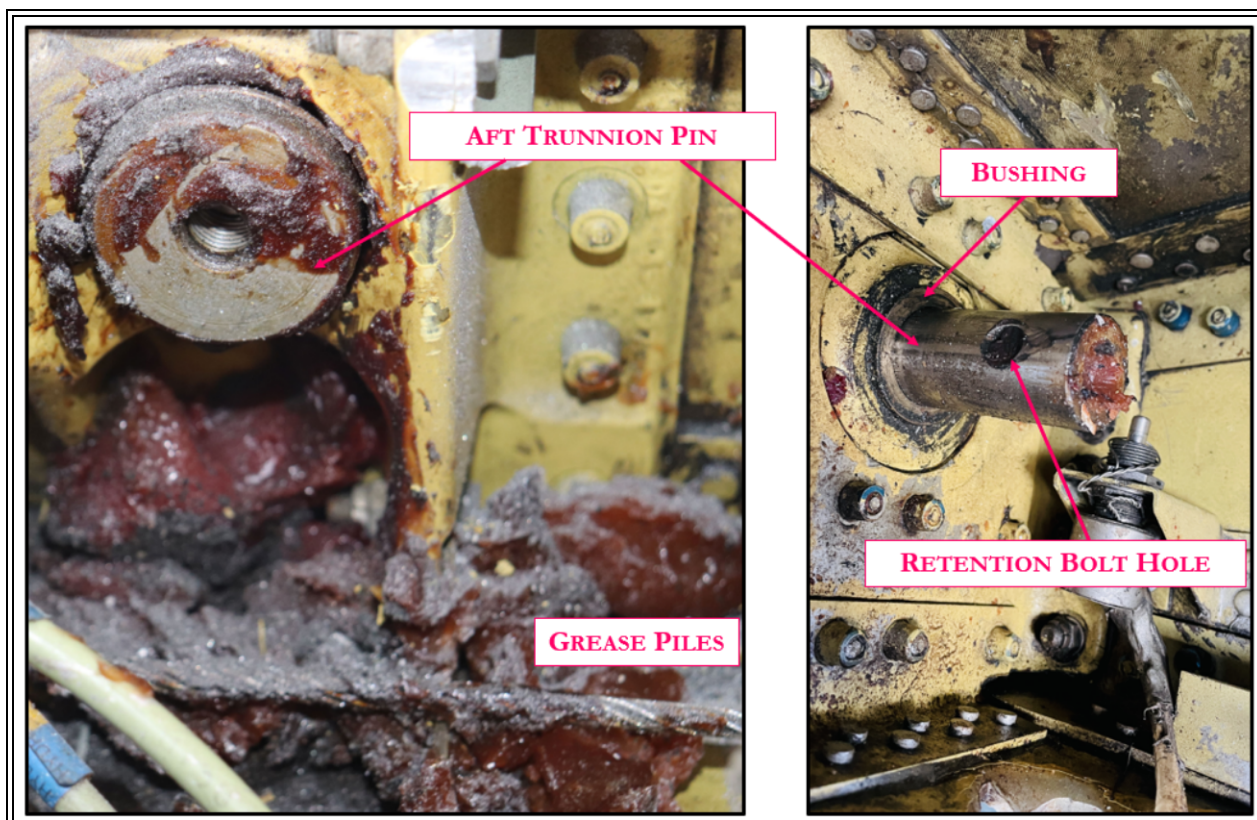
The left outboard gear door was not located. The inboard landing gear door was not in the uplock position. Examination of the left wheel well revealed that the aft trunnion pin was still in the aft trunnion fitting (located on spar #7) with no forward shims located. Removal of the access panel adjacent to the aft trunnion fitting gave investigators visual access to the aft trunnion pin's shoulder and the aft shims. There was an excessive amount of grease piled below the pin (see figure 7).

Figure 7: Left main landing gear aft trunnion pin

The airplane flight time and cycles between the maintenance conducted following the June 2024 incident, and the accident flight are unknown. A mechanic who performed the landing gear servicing in December 2024 stated that nothing appeared unusual but remarked that the left landing gear took an excessive amount of grease.

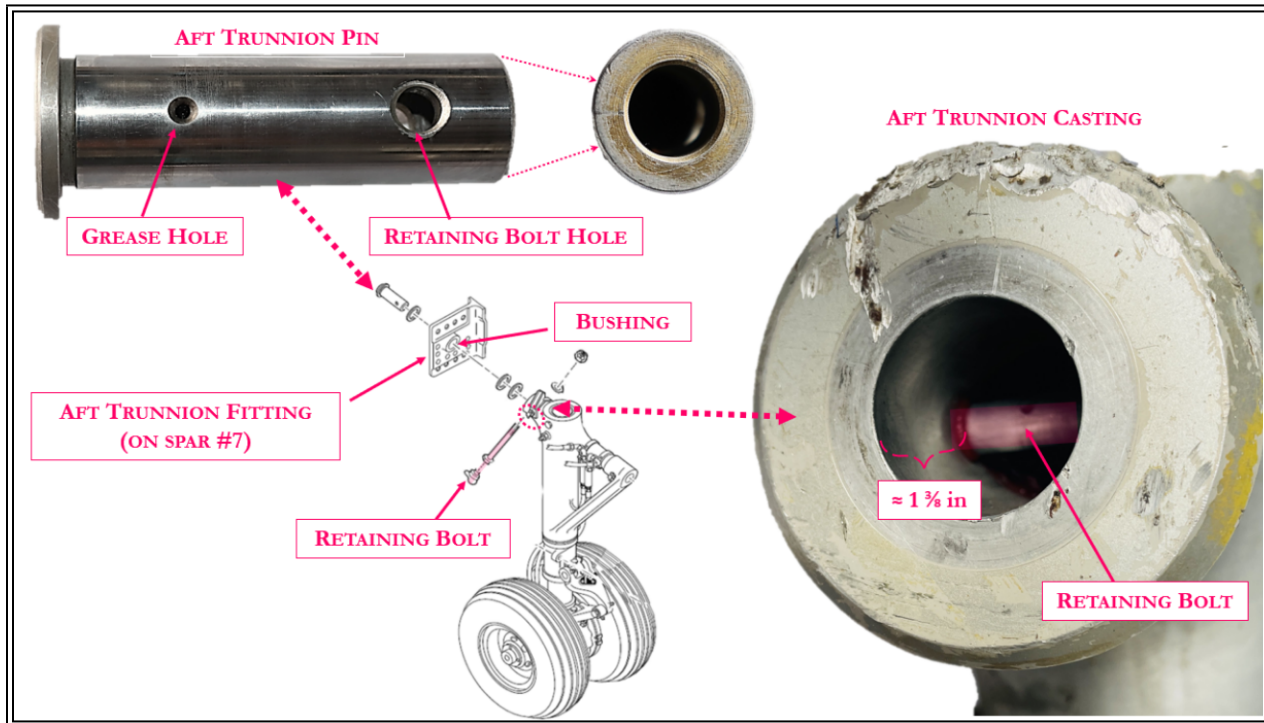
The Learjet manual specifies that installation of the main gear strut begins by securing the forward trunnion pin. The mechanic then should raise the shock strut so that the forward trunnion pin engages in the forward bearing. Thereafter, the mechanic should align the trunnion with the aft trunnion fitting. The same number of shims as previously removed should be placed onto the aft trunnion pin before inserting it from the aft side of spar 7 and then into the trunnion casing, ensuring all shims remain undamaged. A temporary bolt is installed on the shoulder area of the aft trunnion pin to check tolerances, after which the bolt is removed to insert the striker bracket. Finally, the mechanic secures the retaining bolt (with attached Zerk fitting) through the aft trunnion pin and trunnion casing with a nut and cotter pin on the other side. The mechanic then must check the tolerance between the aft trunnion casing and aft trunnion fitting. Thereafter, grease is added through the Zerk fitting to migrate through the pin and grease the bushing through the grease hole (see figure 8).

Investigators took measurements of the aft trunnion pin shoulder protrusion off the aft trunnion fitting if it was not engaged fully forward into the trunnion casing. If the bolt is secured before engaging the

pin in the trunnion casing then the grease hole could be aft of the bushing allowing grease to escape outside the pin, into the wing bay behind spar #7. With the adjacent access panel removed, using a mirror, the pin can visibly be seen not making contact with the aft trunnion fitting when it is not fully pushed into the trunnion casing. The NTSB is aware of at least three other prior events where a Learjet landing gear had disconnected from the airframe because the retaining bolt was not engaged through the aft trunnion pin.

Figure 8: Left main landing gear aft trunnion pin showing bolt installed.
