Highway-Railroad Grade Crossing Collision  
Commerce Street  
Valhalla, New York  
February 3, 2015

NTSB/RAR-17/01  
PB2017-102658

# Railroad Accident Report

**Abstract:** On February 3, 2015, at 6:26 p.m., a vehicle driven by a 49-year-old woman, traveled northwest on Commerce Street in Valhalla, New York, toward a highway-railroad grade crossing. The driver entered the boundary of the grade crossing and stopped. The driver then moved beyond the boundary and stopped adjacent to the railroad tracks. The grade crossing warning system activated and the gate came down, striking the rear of the vehicle. She exited her vehicle, examined the gate, then returned to her vehicle and moved forward on to the tracks. Meanwhile, a Metro-North Railroad train approached the grade crossing. The engineer activated the emergency brakes and collided with the vehicle at 51 mph. The train and the vehicle continued north, damaging the electrified third rail which pierced the vehicle and penetrated the lead railcar. Five passengers died and nine passengers and the engineer were injured, all in the lead railcar. The driver of the vehicle also died. The NTSB made new recommendations to the Federal Trans

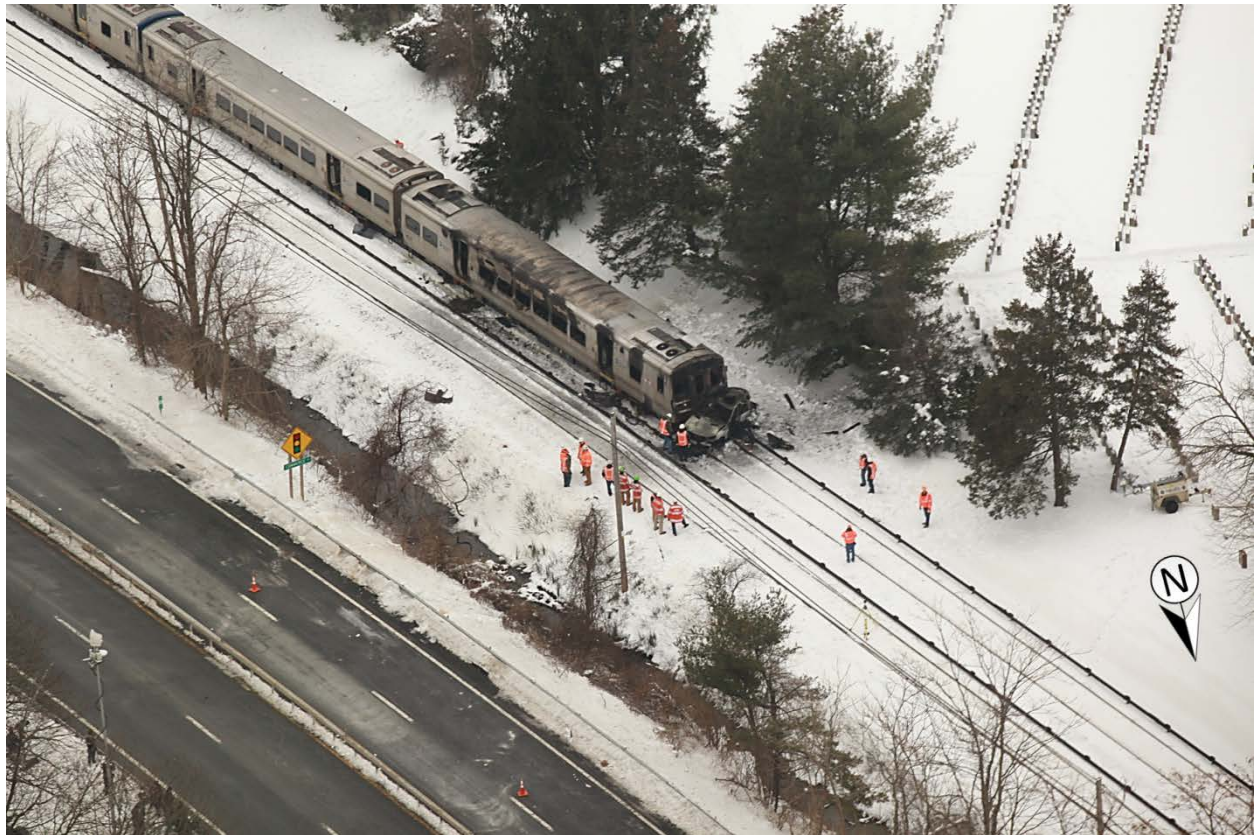
**Figure 1.** Metro-North train 659 on track 2 after collision with the SUV.

Metro-North train 659 was traveling north on track 2 toward the Commerce Street grade crossing when it struck the SUV on its passenger side door and pushed it about 665 feet north on the tracks before stopping. During the collision, the electrified third rail first pierced the SUV on its left side under the rear passenger seats, then pierced its fuel tank, and subsequently exited the SUV on the right side, below the frame and behind the right-side rear wheel. As the train and SUV continued to move, the rail was shoved under the left-side front portion of the lead railcar, and subsequently penetrated it from the underside in two locations near the left-side front passenger doorway. (See figure 2.)

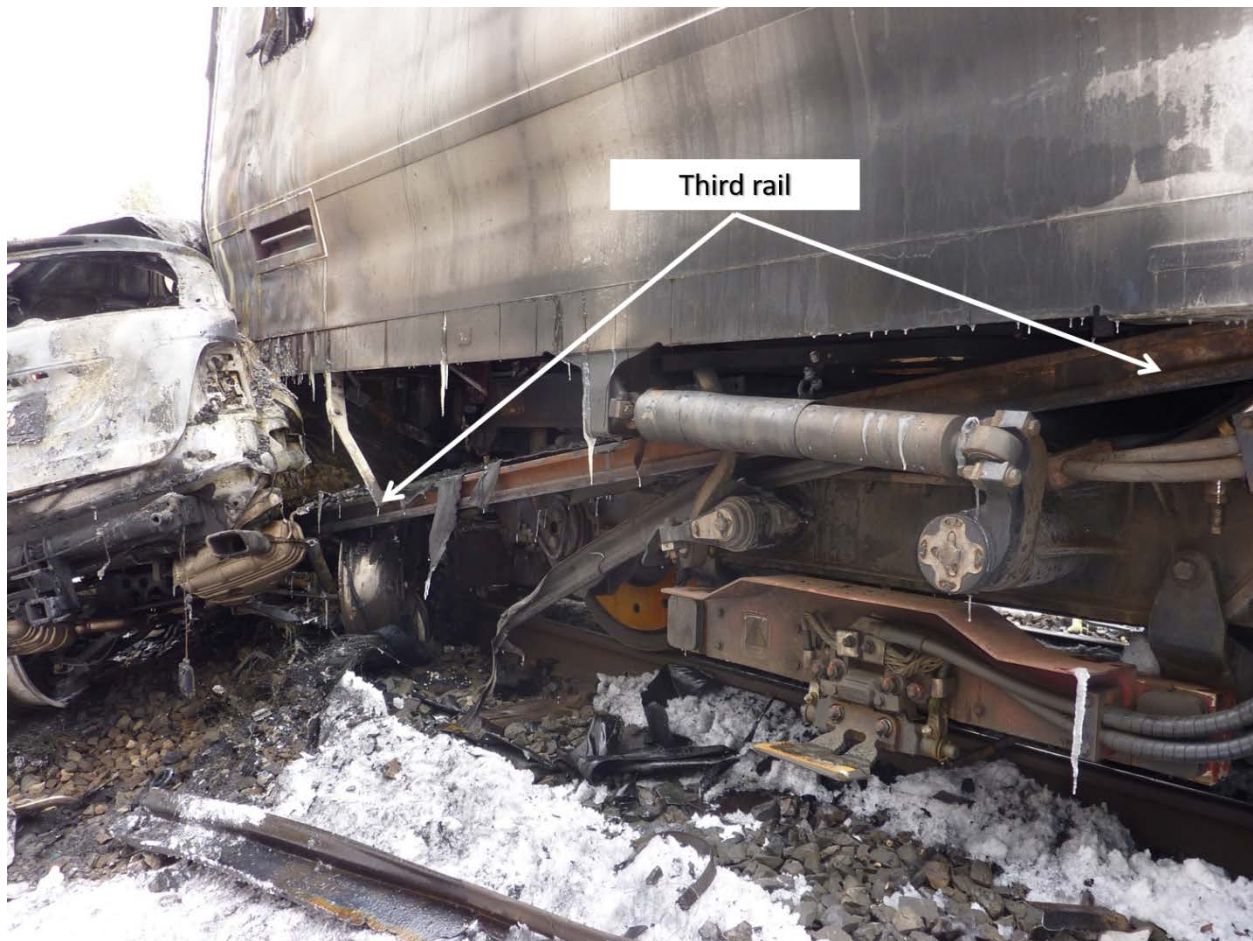
**Figure 2.** Photograph of the SUV and Metro-North train 659 after the collision.

An estimated 386 feet of third rail was damaged, including 11 sections totaling about 343 feet that penetrated the passenger compartment of the lead railcar. A fire ignited that consumed both the SUV and the interior compartment of the lead railcar. (See figure 3.)

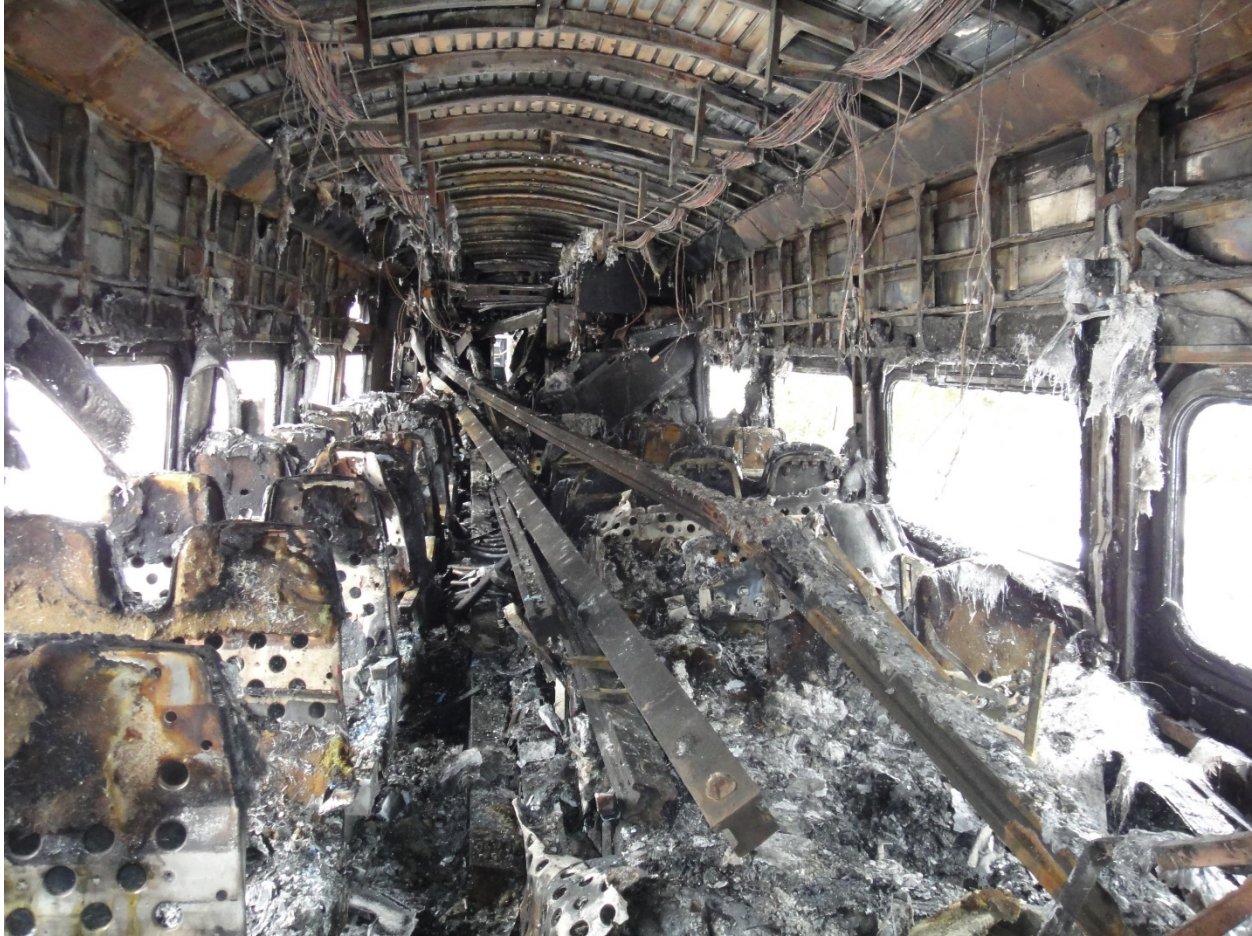
**Figure 3.** Postaccident photograph of the interior of the lead railcar.

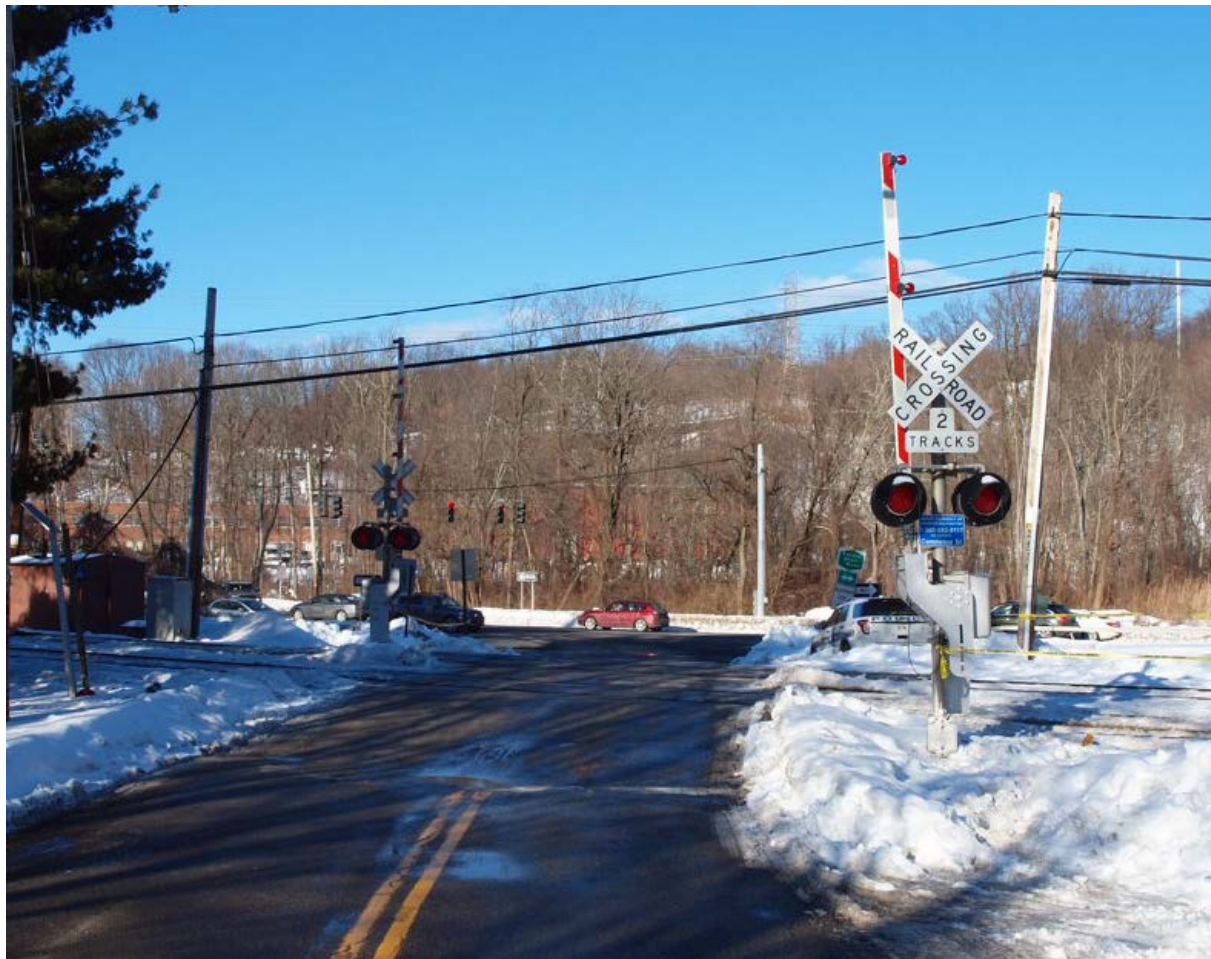
Postaccident testing confirmed that when the warning system activated, the light unit mounted at the tip of the gate arms remained lit, while the other two light units flashed alternately. Both signal masts had signs affixed with a toll-free telephone number to report emergencies.

**Figure 10.** Approach of the Commerce Street grade crossing, facing northeast.

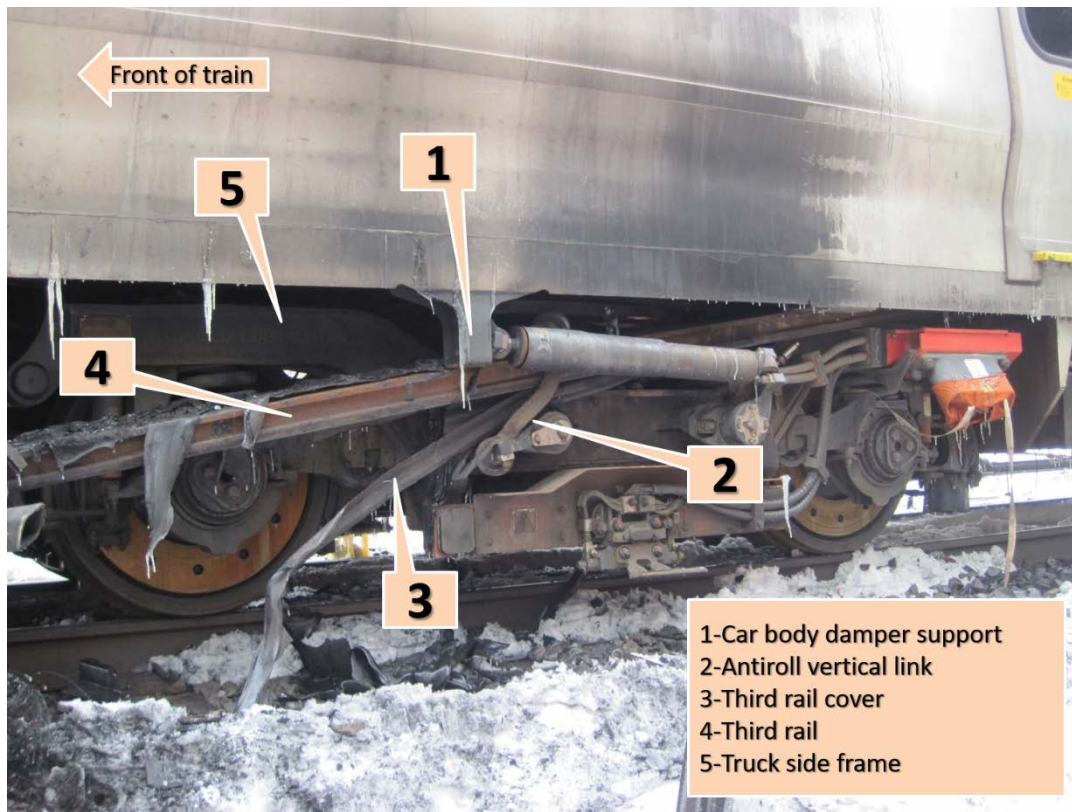
At the lead railcar, the third rail was forced between the left-side antiroll vertical link and the truck side frame assembly. (See figure 15.) Investigators found segments of burned third rail cover on top of the truck and the third rail. As the rail continued past the antiroll vertical link, it angled upward and made its first entry into the passenger compartment of the lead railcar, introducing sparks and flaming debris into the railcar, contributing to a fire, which will be discussed in section 1.8.3.

**Figure 15.** Path of the third rail entry into Metro-North 4333.

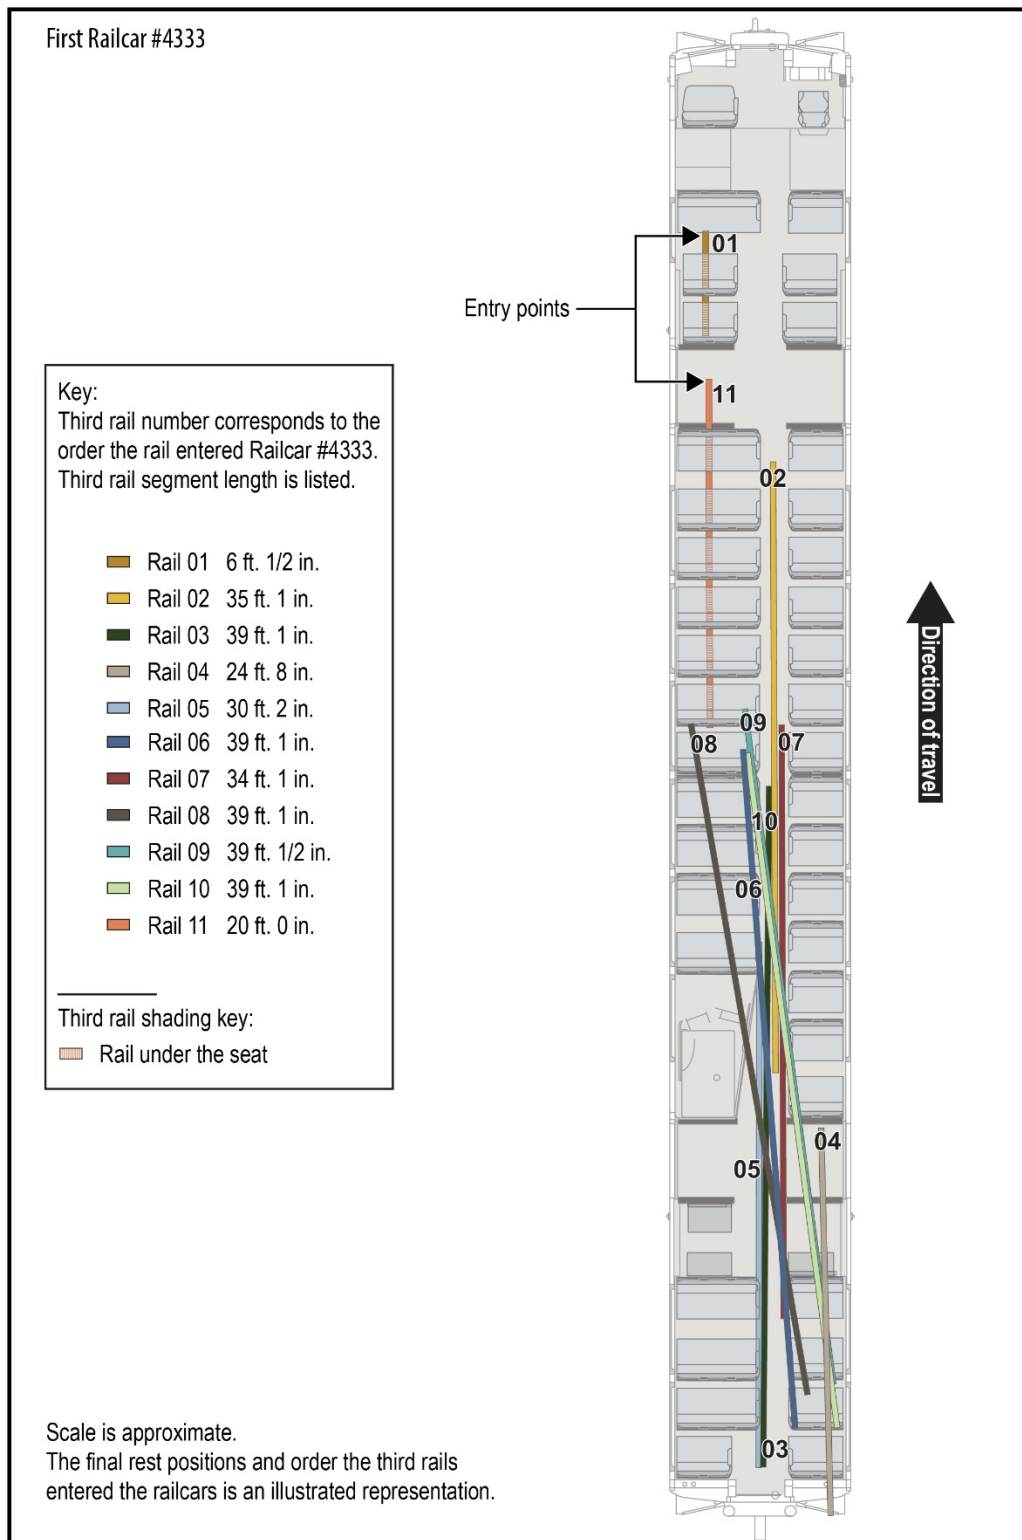
The third rail entered the lead railcar in two locations. One section of the third rail punctured a hole into the exterior subfloor under the railcar, about 8 feet from the left-side front corner of the car. (See figure 16.) This hole extended through the floor into the passenger compartment. In the interior of the railcar, the hole was located under the first row of passenger seats, behind the left-side electrical locker. At this location, the nose piece of the third rail, a segment about 6 feet-long, came to rest between the center hand holds of the second seat row.

The second entry point punctured the railcar's exterior subfloor near the left-side front passenger doorway, about 18 feet from the left-side front corner of the car. The third rail then continued into the interior of the car, under the first row of passenger seats behind the vestibule. Overall, 11 sections of third rail entered the lead railcar and came to rest in the passenger compartment. (See figure 16.)

**Figure 16.** Entry points and the approximate position of the third rail inside the lead railcar.

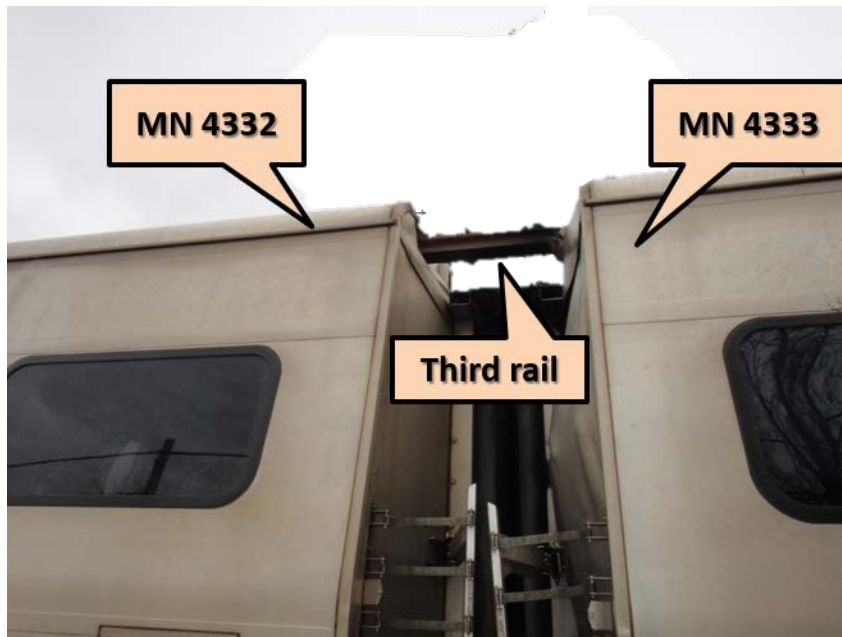
One third rail section pierced through the top right-side rear of the lead railcar and punctured the second railcar, Metro-North 4332. The third rail lodged inside the second railcar between the exterior car body shell and the interior ceiling panels. (See figure 17.)

**Figure 17.** Third rail between railcars Metro-North 4332 and 4333.

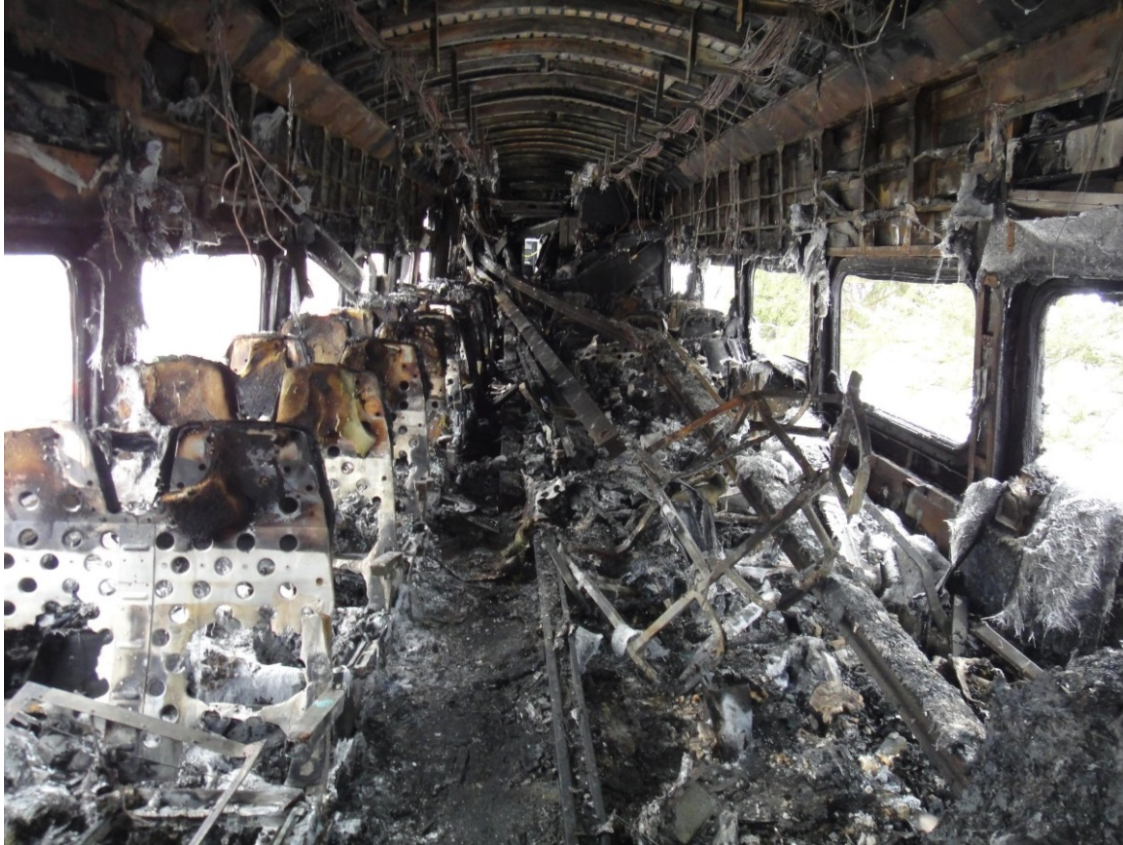
In the center section of the lead railcar, the left-side seat frames and backs bent toward the rear of the railcar. The right-side seat frames generally were secure in their correct position. Sections of broken overhead baggage racks scattered throughout the car. (See figure 18.) The railcar's rear door was impassible and could not be used because one section of the third rail prevented the door from opening.

**Figure 18.** Interior of the lead railcar, front to rear.

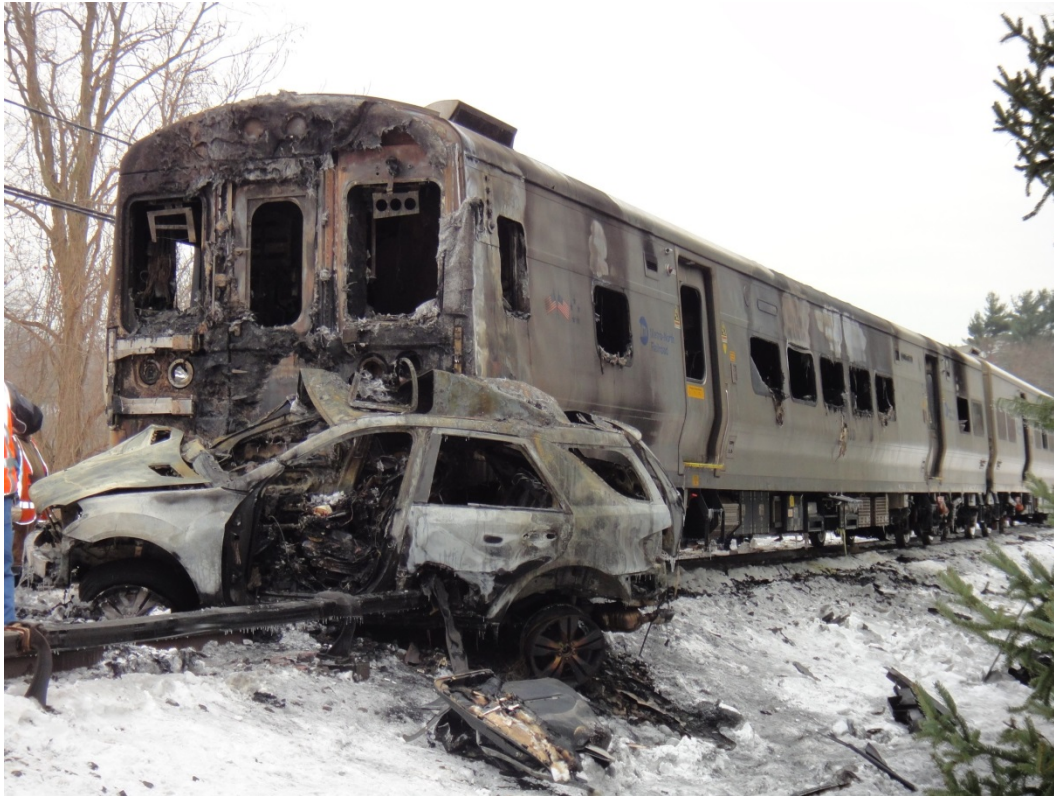
Outside the left side of the lead railcar, investigators found the rear emergency exit window on the ground; however, the accompanying zip strip and window gasket were inside.<sup>34</sup> The second window in the rear section of the railcar was in place, but all remaining windows on the left side of the railcar were melted or missing. The emergency access window from the front side passenger door was found on the ground outside of the railcar, although its exterior zip strip remained in place in the door. The left-side passenger doors would not open, and there was thick soot near the window openings on the left side of the railcar. (See figure 19.)

**Figure 19.** Left side of the lead railcar.

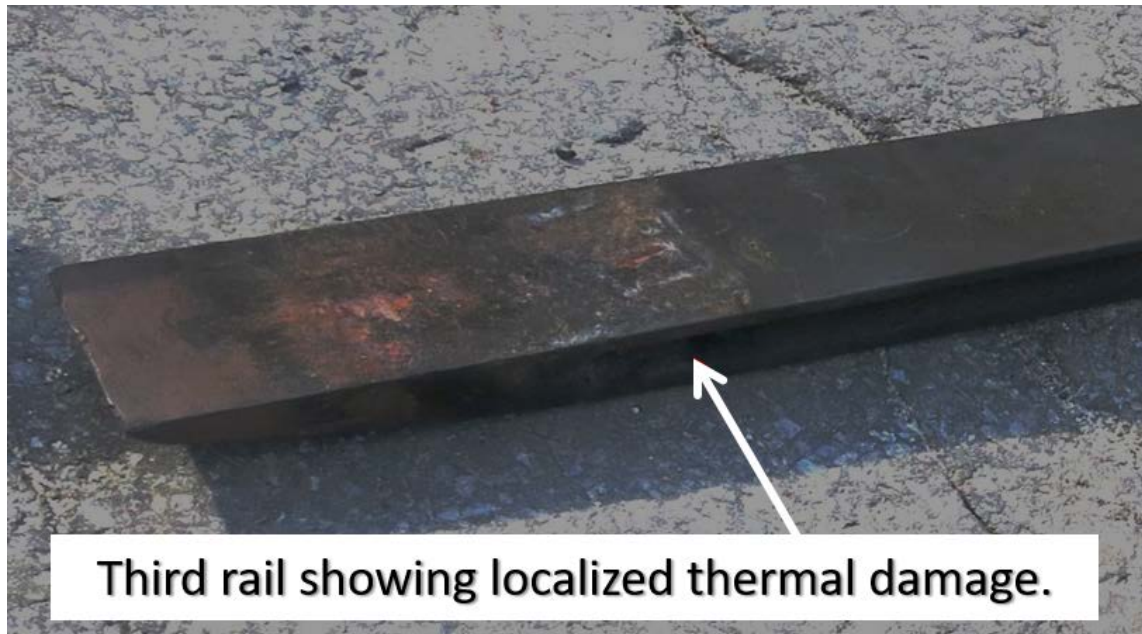
The railcar structure showed no obvious signs of electrical arcing. Two rails—the nose piece and the rail removed from the SUV—exhibited atypical, localized thermal damage on the surface of the rail. (See figures 20 and 21.)

**Figure 20.** Localized thermal damage to the third rail nose piece surface removed from the lead railcar.

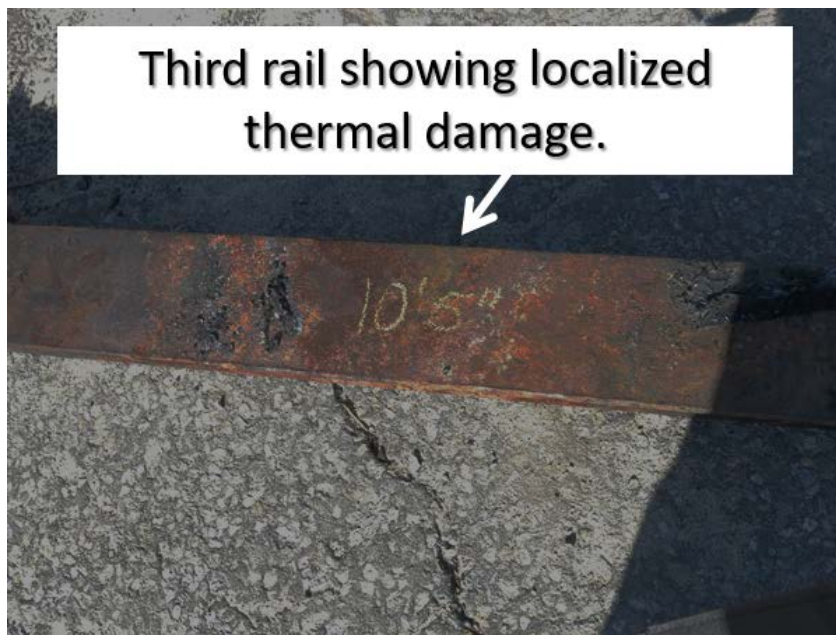
**Figure 21.** Localized thermal damage to the surface of the third rail removed from the SUV.

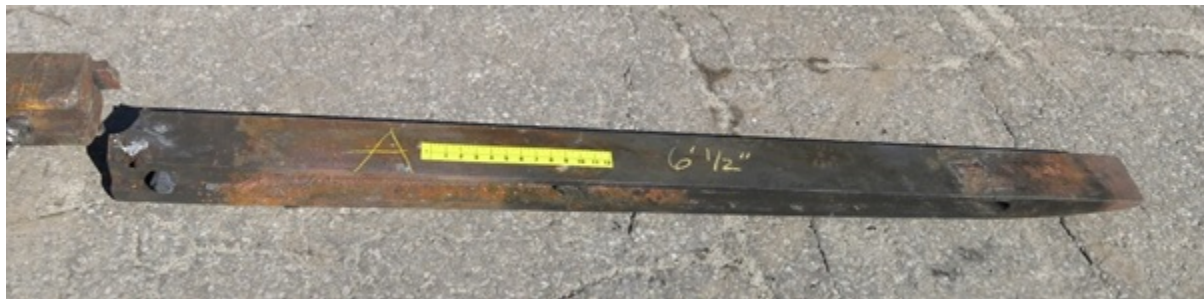
The third rail nose piece is a 6-foot section of tapered rail attached at the ends of the regular third rails to smoothly transition the current collector shoes from the trains on to the third rail. (See figure 22.) This section of the third rail was the first part to puncture the lead railcar's underside structure and enter the passenger compartment.

**Figure 22.** Third rail nose piece involved in this accident.

During postaccident examinations of recovered third rail sections from inside the lead railcar, investigators observed fractures in the splice bars and bolts that joined the third rail together, but found the third rail sections themselves to be intact and unbroken.
