Highway-Railroad Grade Crossing Collision  
Commerce Street  
Valhalla, New York  
February 3, 2015

NTSB/RAR-17/01  
PB2017-102658

# Railroad Accident Report

**Abstract:** On February 3, 2015, at 6:26 p.m., a vehicle driven by a 49-year-old woman, traveled northwest on Commerce Street in Valhalla, New York, toward a highway-railroad grade crossing. The driver entered the boundary of the grade crossing and stopped. The driver then moved beyond the boundary and stopped adjacent to the railroad tracks. The grade crossing warning system activated and the gate came down, striking the rear of the vehicle. She exited her vehicle, examined the gate, then returned to her vehicle and moved forward on to the tracks. Meanwhile, a Metro-North Railroad train approached the grade crossing. The engineer activated the emergency brakes and collided with the vehicle at 51 mph. The train and the vehicle continued north, damaging the electrified third rail which pierced the vehicle and penetrated the lead railcar. Five passengers died and nine passengers and the engineer were injured, all in the lead railcar. The driver of the vehicle also died. The NTSB made new recommendations to the Federal Trans

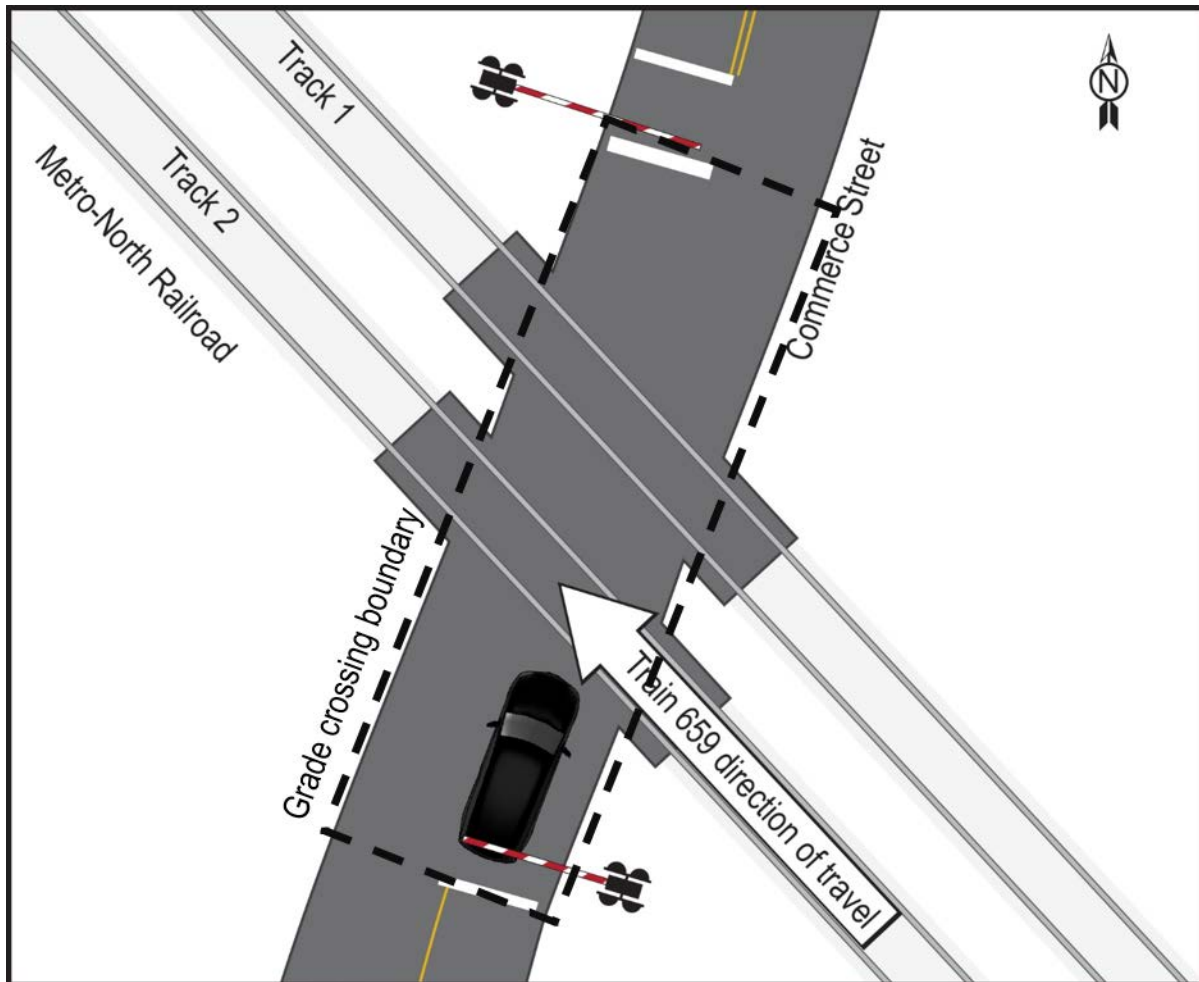
sitting within the boundary of the grade crossing when the warning system at Commerce Street activated. (See figure 5.)

**Figure 5.** Illustration of the grade crossing with the gate arm on the rear of the SUV. (Not to scale.)

Investigators asked the witness if the gate arm struck the SUV while it was moving; he answered, “No; it [the SUV] was stopped.” According to the witness, the gate arm lowered on to the rear portion of the SUV. The witness said he looked in his rearview mirror, saw no vehicles behind him, and backed up his vehicle, believing the SUV driver would do the same. The witness said that after he backed his vehicle up about one car-length, he saw the driver of the SUV exit the vehicle, slowly walk around to the rear of the SUV, and touch the gate arm. He characterized the driver’s behavior as calm, and presumed it was because the SUV was not on the track. He said that the front of the car was “just barely making it,” and he believed that the front of the SUV was very close to—but not on—the railroad track.

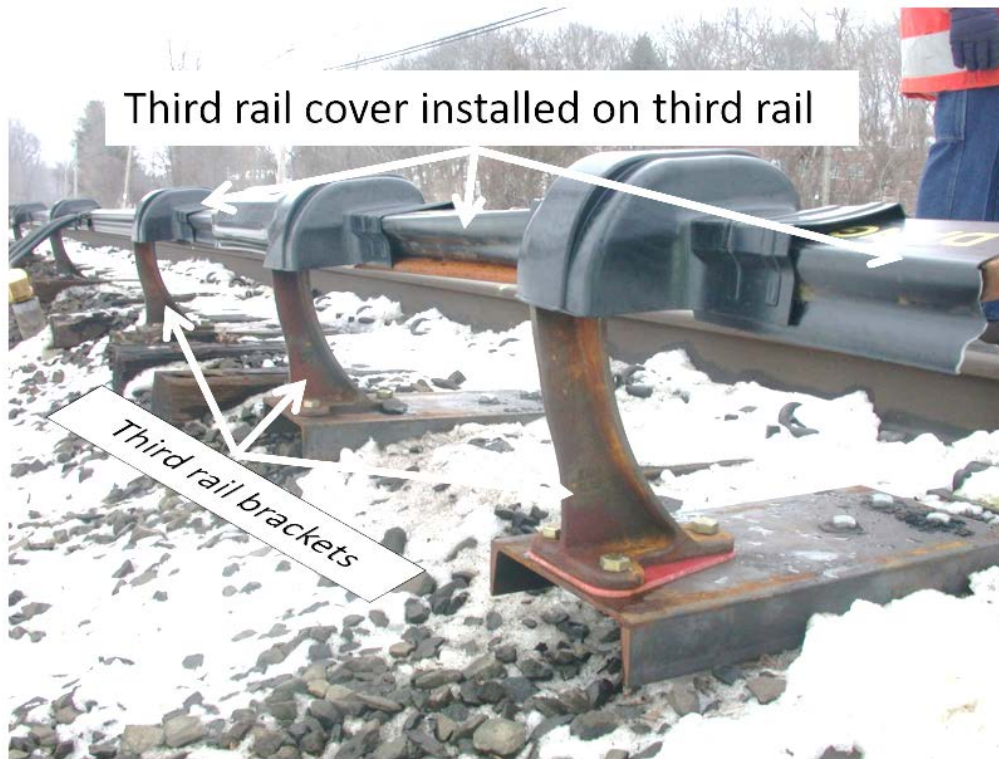
power to operate from the bottom side of the rail. The third rail has a protective cover. (See figure 13.)

**Figure 13.** Metro-North's third rail configuration.

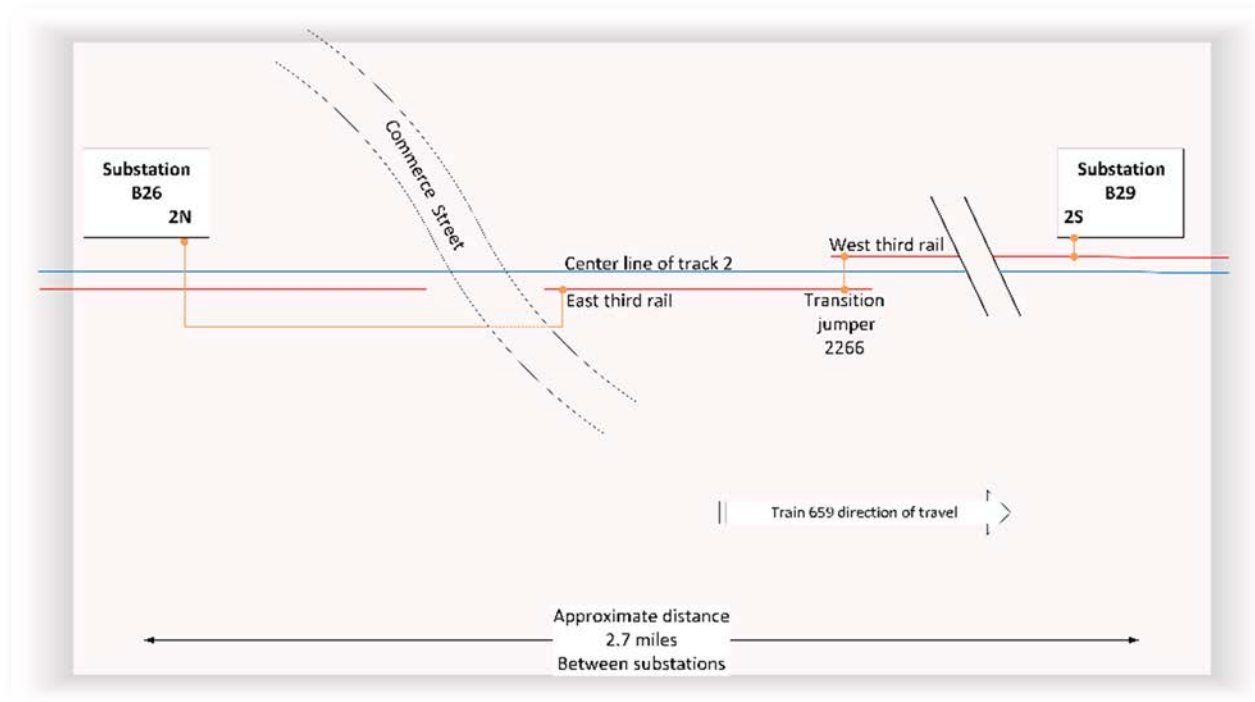
**Figure 14.** Simplified electrical schematic of traction power substations near Commerce Street. (Not to scale)

After the accident, as train 659 and the SUV continued to move north, they physically damaged transition jumper 2266, located about 300 feet north of the POC. (See figure 14.) The damage caused the east and west third rails to electrically disconnect from each other and isolated substation B26 electrically from the damaged west third rail.

As a result of damage to transition jumper cable 2266, the load measuring circuitry at substation B26 for the track 2 north circuit breaker was no longer detecting a fault on the east side of track 2 and re-energized. The reclose feature re-energized the east third rail at 6:26:28 p.m., 7 seconds after the circuit breaker tripped. This re-energized the last four cars of the train, which were contacting the east third rail.

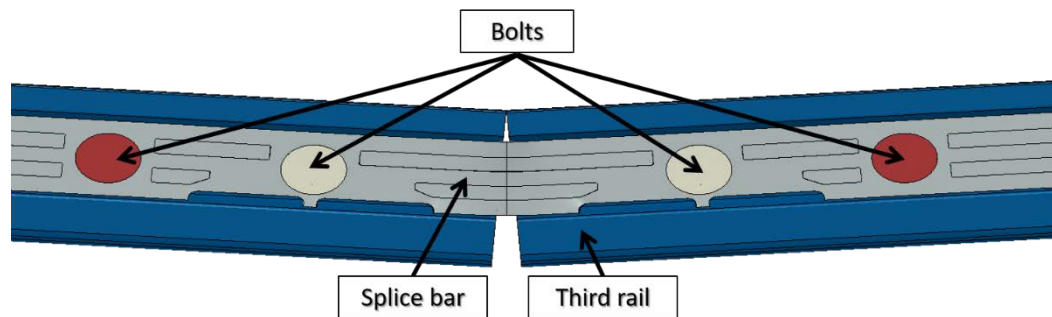
The model considered two modes of deformation: in-plane (up-and-down) and out-of-plane (side-to-side) bending. (See figure 23.) Investigators chose these modes based on the entry path of the third rail into the lead railcar during this accident. Figure 23 shows the finite element model of the third rail, splice bar, and bolts demonstrating in-plane bending.

**Figure 23.** Illustration of third rail and splice bar subjected to in-plane bending.

In both analyses, investigators used compressive loads to simulate the forces the SUV and the train exerted on the rail and splice bar assemblies during the accident. The analyses showed Metro-North's third rail splice bar system would have undergone large deformations before failing.
